Plywood joint lines and surface imperfections

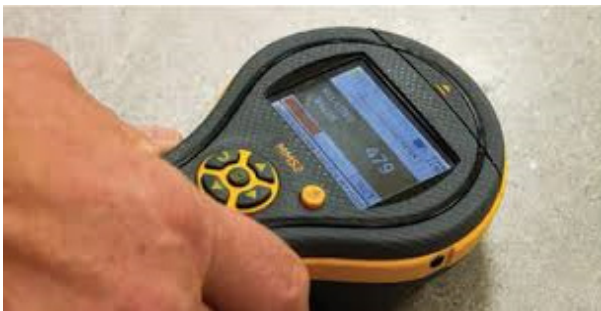
This is not an uncommon occurrence as joints or imperfections can often mirror through the completed Luxury Vinyl Tiles (LVT) and other resilient floor coverings, particularly when the floor is shown in critical lighting conditions.

By using flooring grade plywood which is compliant with BS 8203: 2017 Annex A, the built-up subfloor will have the best chance of coping with factors which may influence any potential shadow through to the finished vinyl floor.

Attention to detail regarding methods of fixing plywood, filling of joints and application of suitable smoothing compound is something that installers now recognise to be of great importance. If this is not done correctly the floor will not perform to a satisfactory standard, which can often lead to expensive remedial works.

Plywood will readily absorb water, especially on the edges of panels where the timber end grain is exposed. This process must be considered when using any materials that carry a high level of water, such as levelling screeds. It is understood that this can be one of the main causes of joint lines when edges expand due to the uptake of moisture. The practice of skimming or feathering joints, followed by sanding after a period of 24 hours, is often favoured by fitters as they look to avoid the issues caused by the introduction of high levels of moisture.
